MACBONE FIELD SERVICE ADVISORY

Subject: Control Valve Stem Packing

Models: All C series MacBone Air Conditioning Units with Production numbers 825 and up

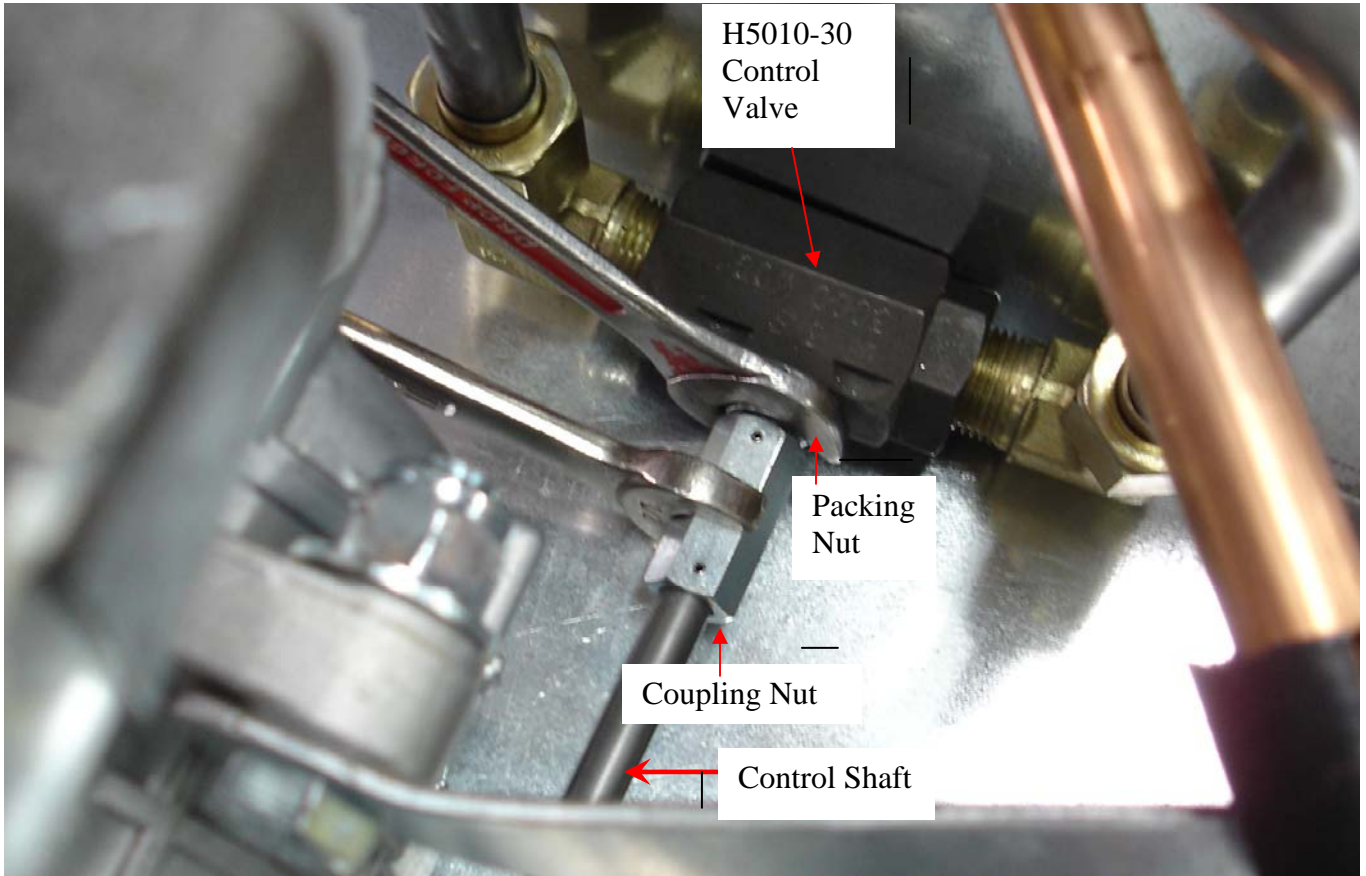
On all of the 24,000BTU/HR, belt driven MacBone air conditioning units, beginning with production number 825, the hydraulic control valve, which is actuated by the blue handle, was changed to a different type. The packing adjustment on this ball valve is different in that when tightening the packing nut, the long hex shaped coupling nut, between the control rod and the valve stem, must be held with a wrench to keep it, the control shaft and the valve stem from turning when the valve stem packing nut is tightened. Failure to hold the coupling nut when turning the packing nut will result in no tightening of the packing.

If the control valve packing is leaking, hold the long hex shaped coupling nut with a ½” end wrench and with a second ½” end wrench, tighten the packing as shown in the attached photo. Tighten sufficiently to stop the leak, 1/8 turn at a time, DO NOT OVERTIGHTEN. Excess tightening will make the blue control handle difficult to turn.

DO NOT try to hold the coupling nut with the blue handle. Hold the coupling nut with a wrench. The torque required to tighten the packing nut can be sufficient to shear the pins in the blue handle and shaft assembly if the nut is not held with a wrench.
